## COMMERCIAL WINDSTORM MITIGATION REPORT

Seville Condominium 7, Inc.

As of 2/28/2019

## COMMERCIAL WINDSTORM MITIGATION REPORT (OIR-B1-1802)

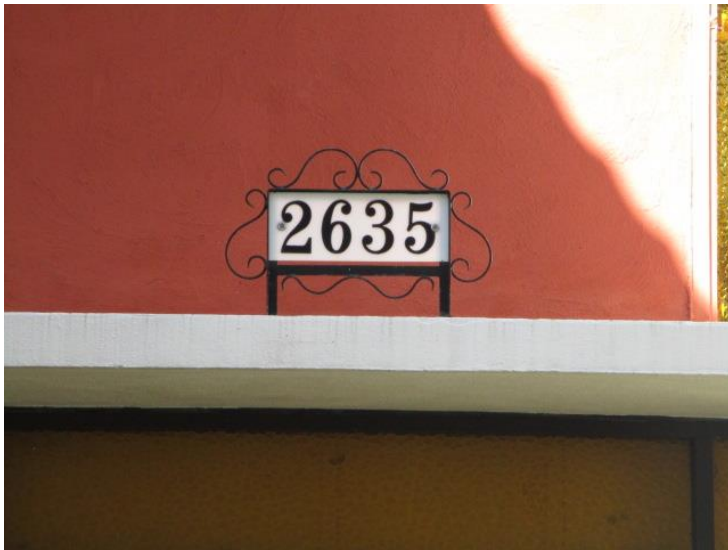
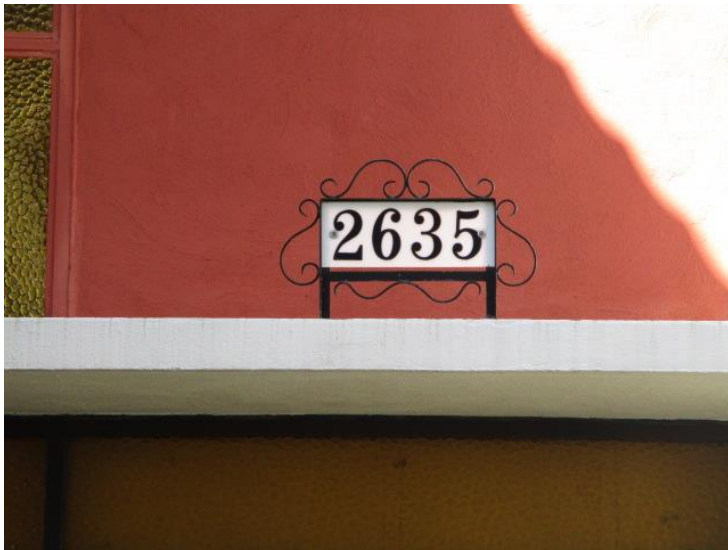
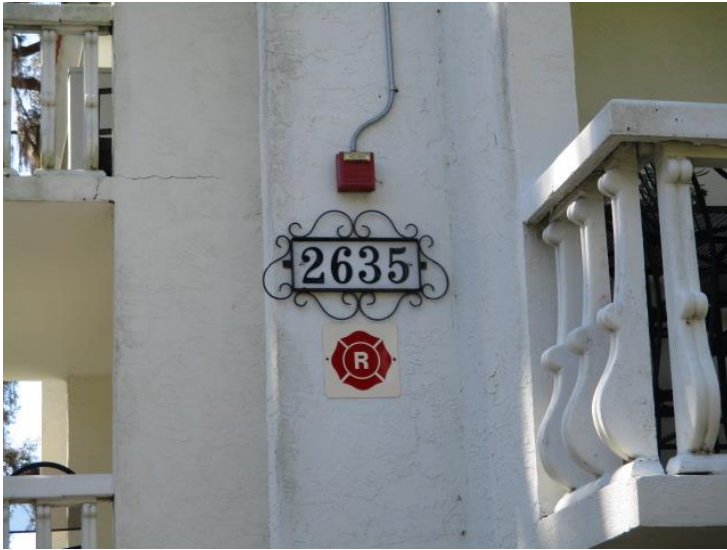
Address Verification

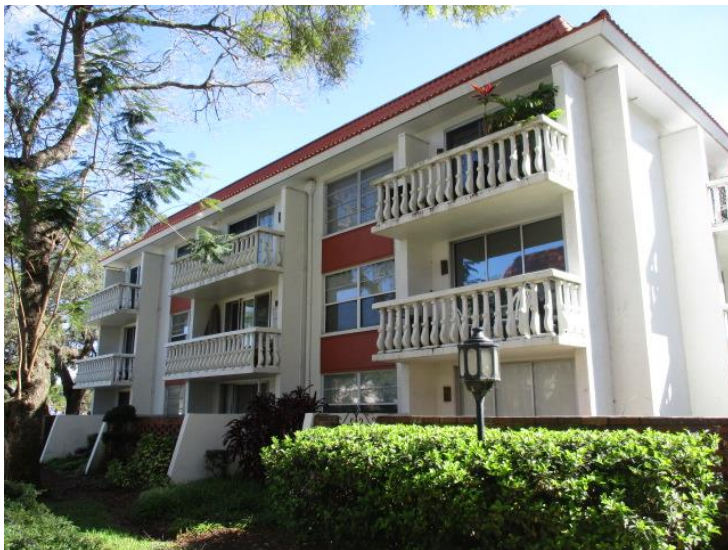
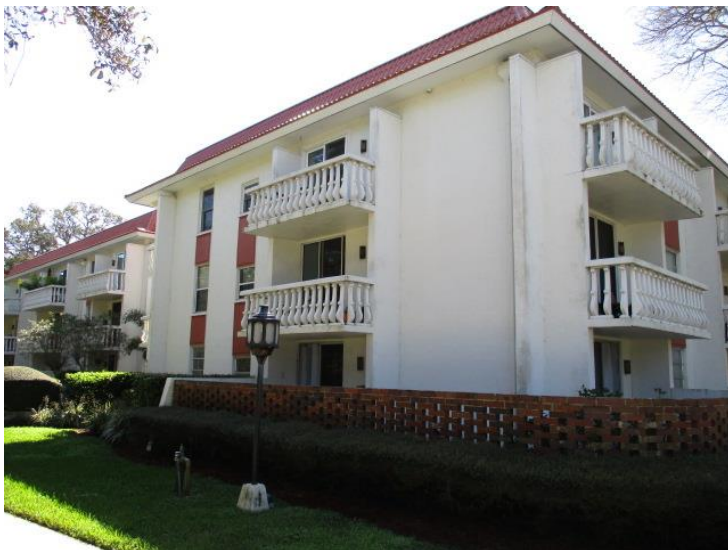
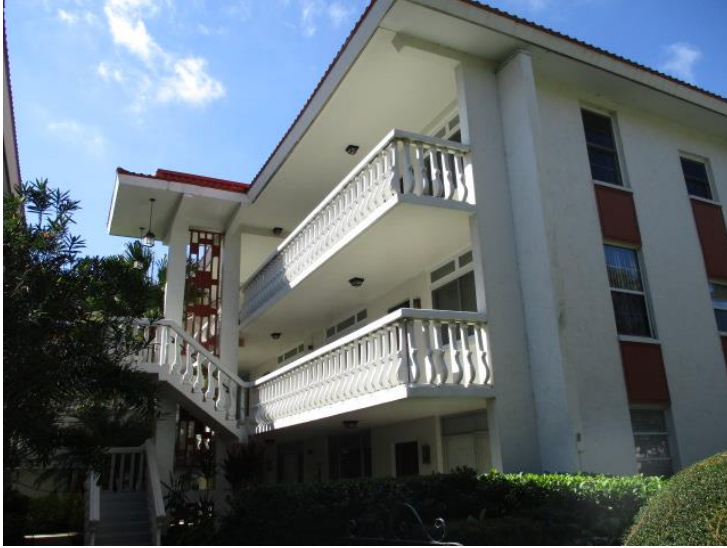
| 7. <b><u>Opening Protection:</u></b><br>Comments: | <b>None or Some Glazed Openings</b><br>Inspection verified no opening protection. |

Exterior Elevation

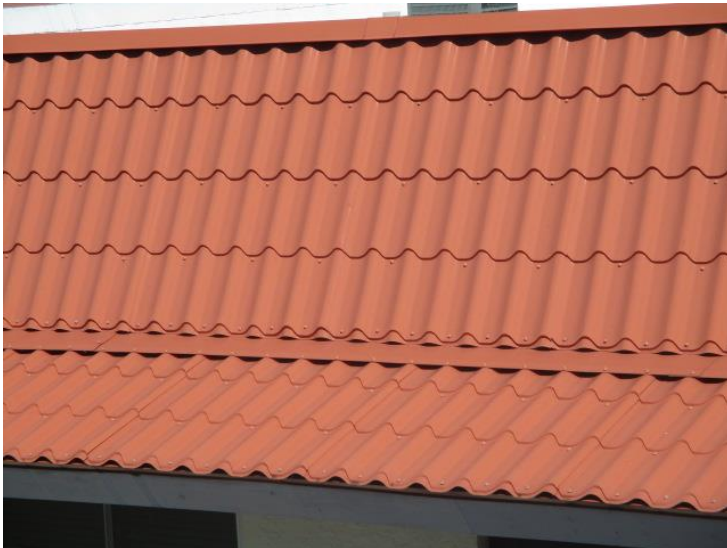
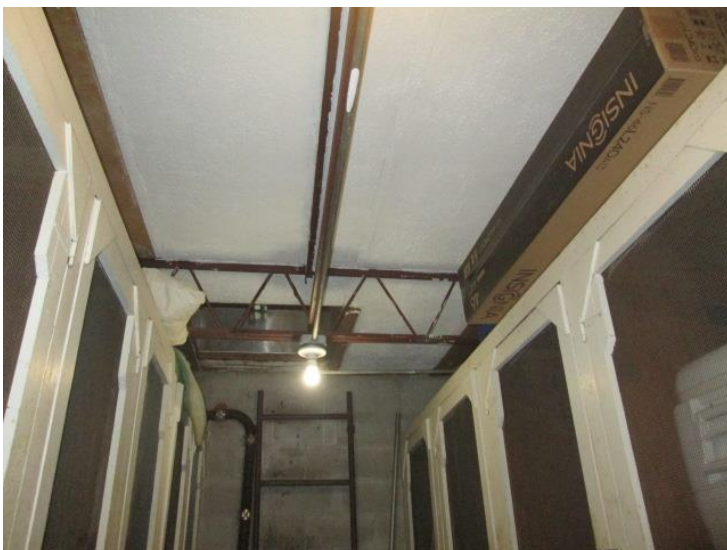
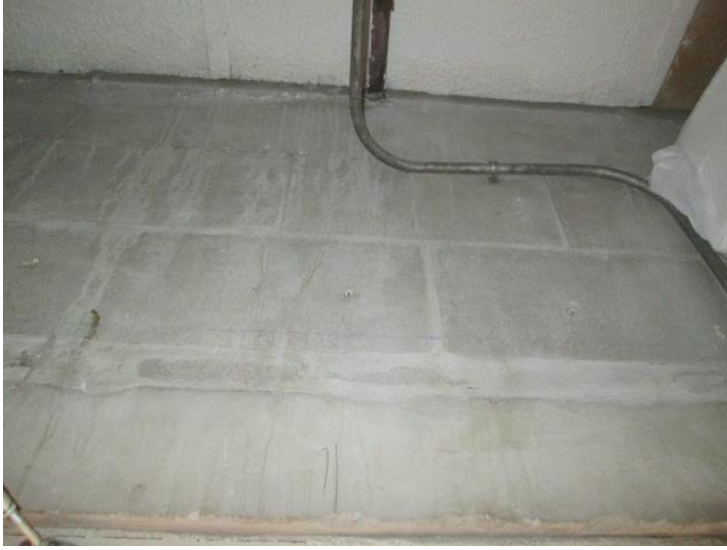
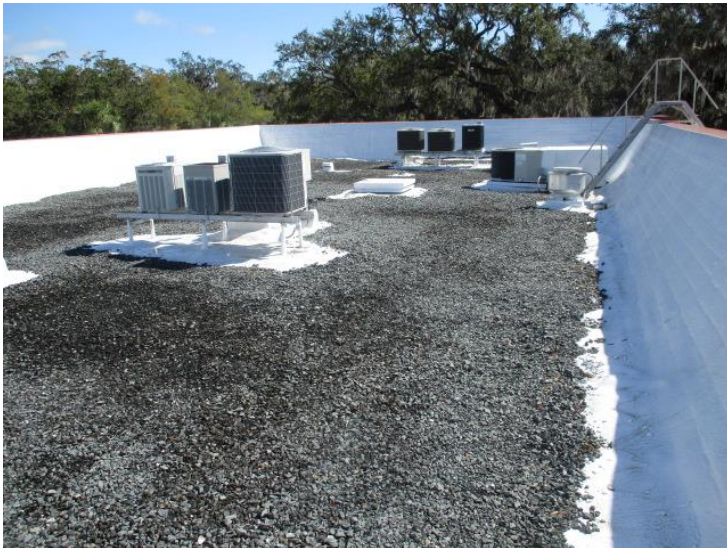
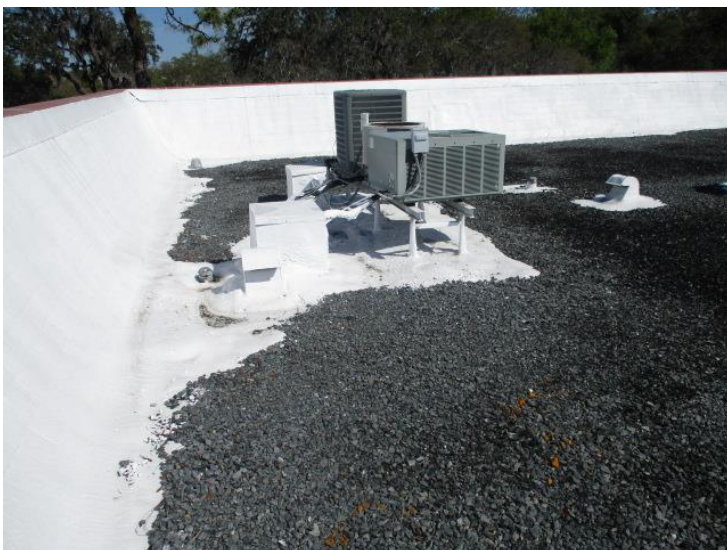
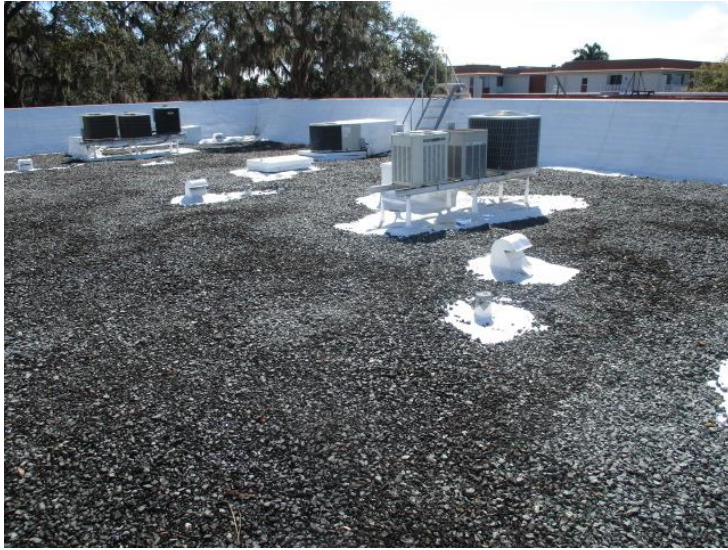
| 3. <b><u>Roof Deck Attachment:</u></b><br>Comments: | <b>Other</b><br>Inspection verified a roof deck composed of lightweight concrete gypsum planks supported by steel bar joists. |
| 4. <b><u>Roof to Wall Attachment:</u></b><br>Comments: | <b>Structural</b><br>Inspection verified a roof-wall connection composed of steel bar joists structurally connected to the wall/support system. |
| 5. <b><u>Roof Geometry:</u></b><br>Comments: | <b>Flat Roof</b><br>Inspection verified a flat roof shape. |

Roof Construction

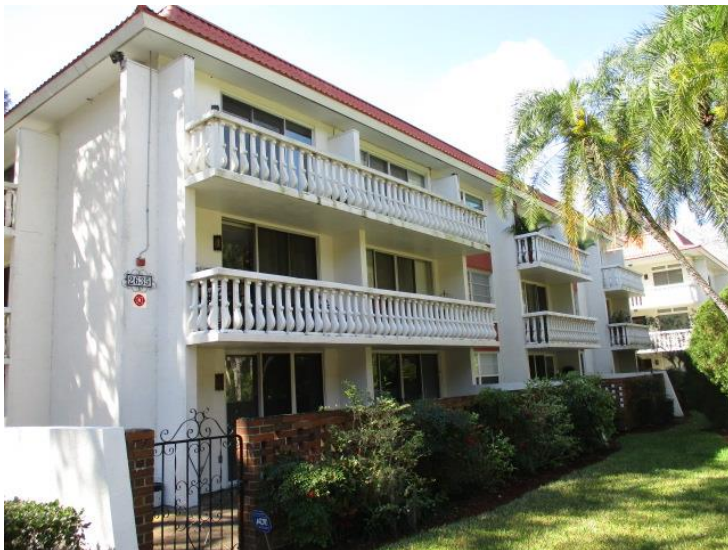
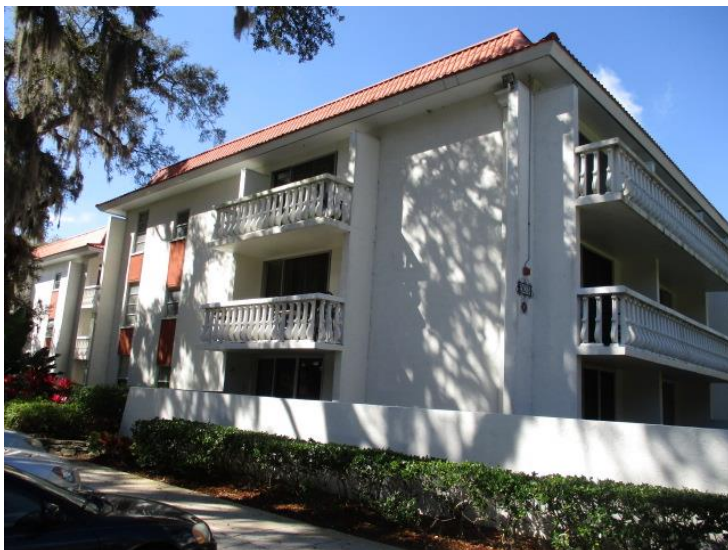
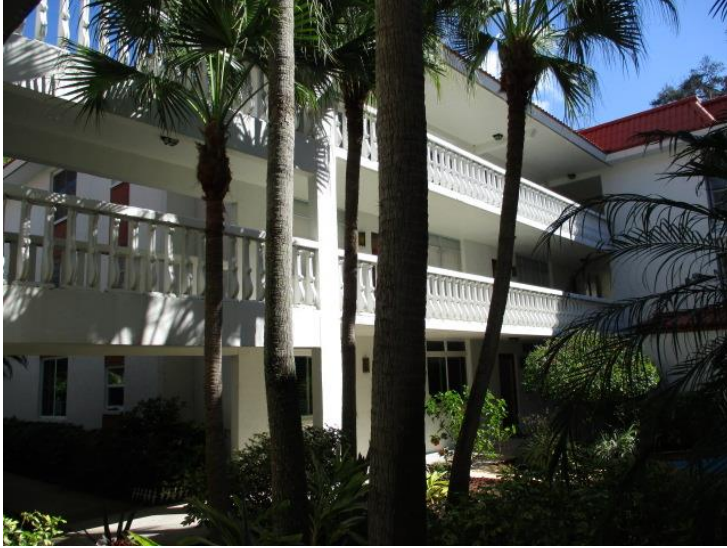
| 7. <b><u>Opening Protection:</u></b><br>Comments: | <b>None or Some Glazed Openings</b><br>Inspection verified no opening protection. |

Exterior Elevation

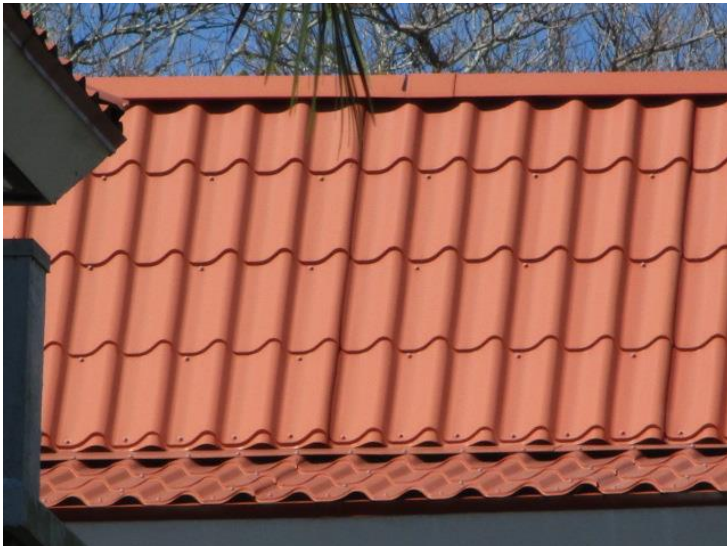
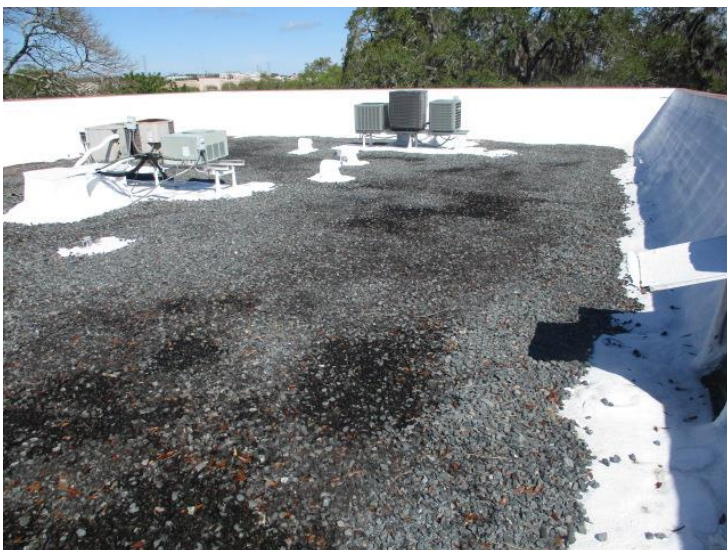
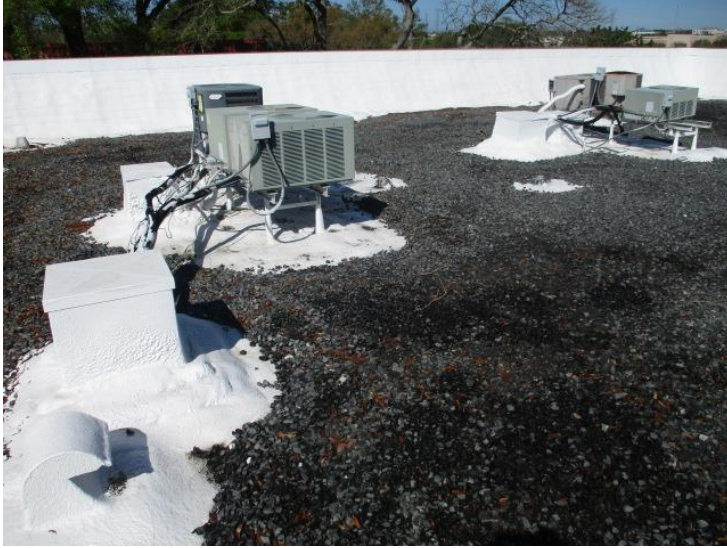
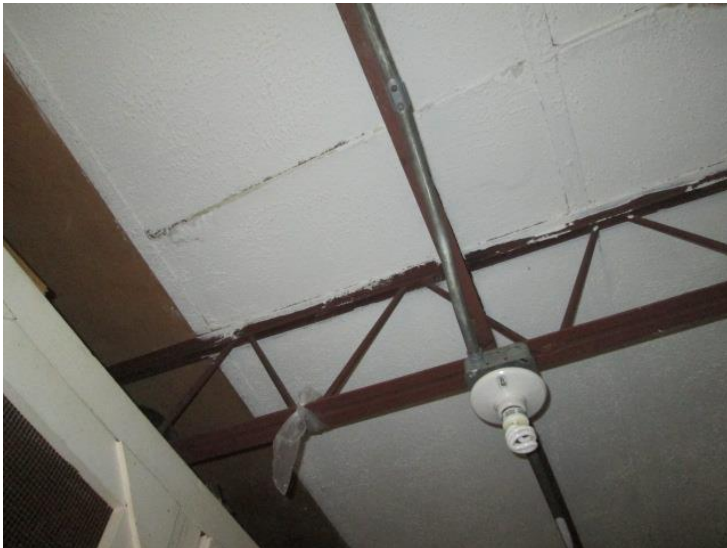
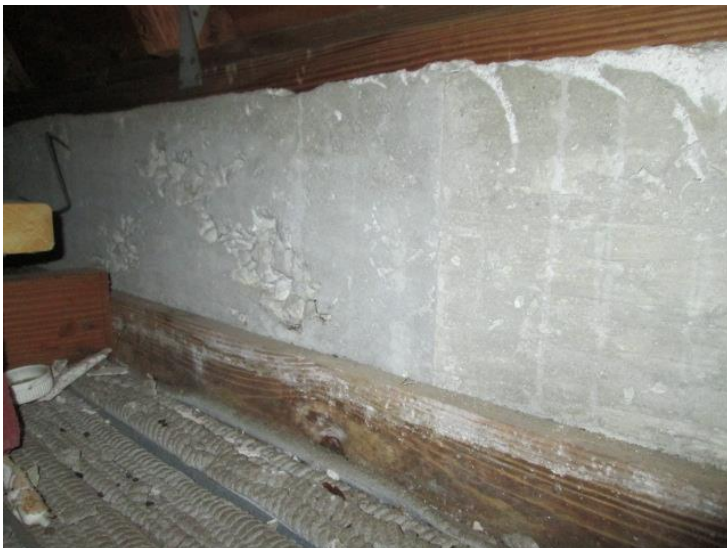
| 2. <b><u>Roof Covering:</u></b><br>Comments: | <b>FBC Equivalent</b><br>The roof covering was replaced in 2004. The roof permit was confirmed and the permit number is BCP2004-02546. This roof was verified as meeting the building code requirements outlined on the mitigation affidavit. |

Roof Construction

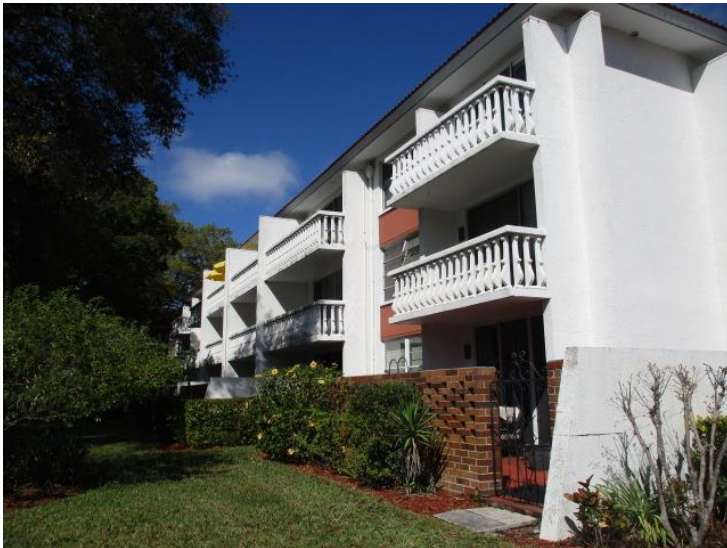
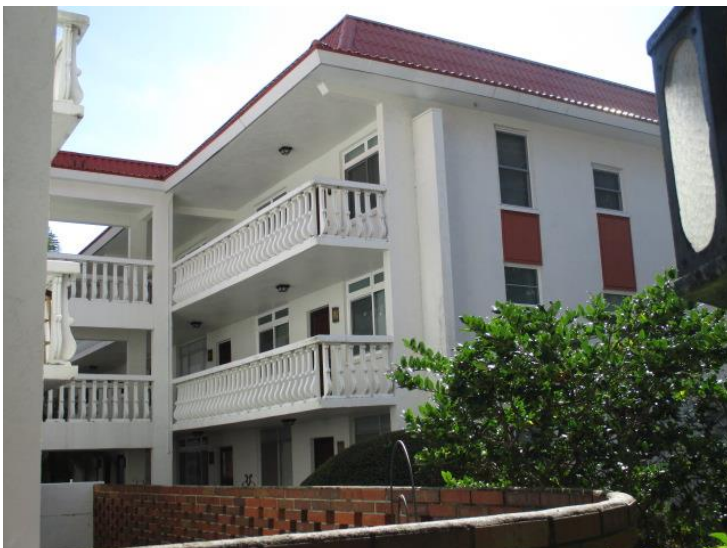
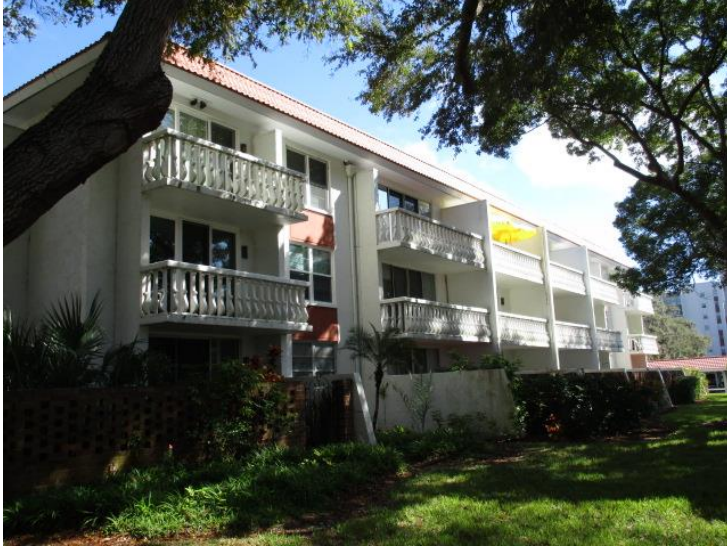
| 7. <b><u>Opening Protection:</u></b><br>Comments: | <b>None or Some Glazed Openings</b><br>Inspection verified no opening protection. |

Exterior Elevation

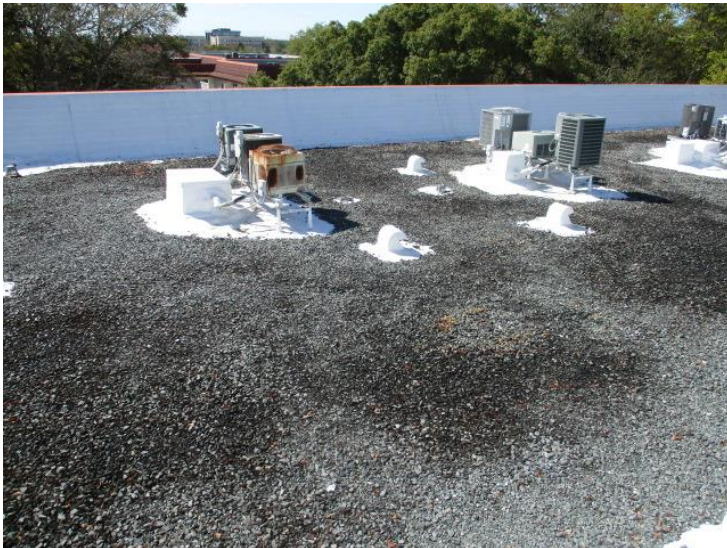
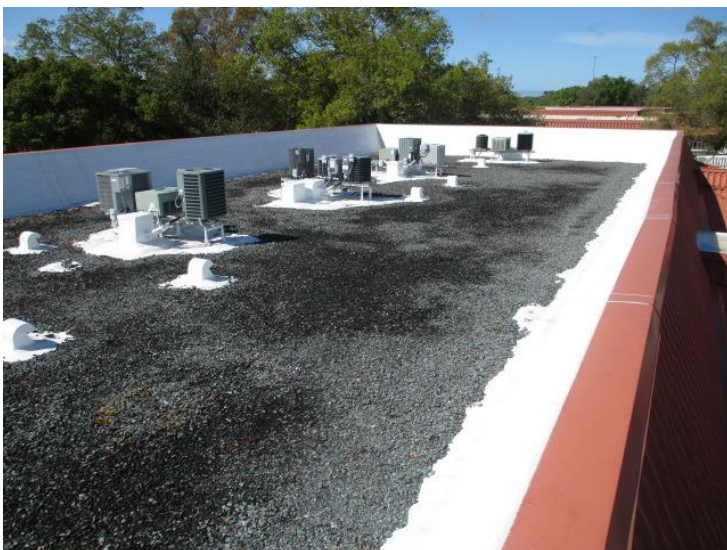
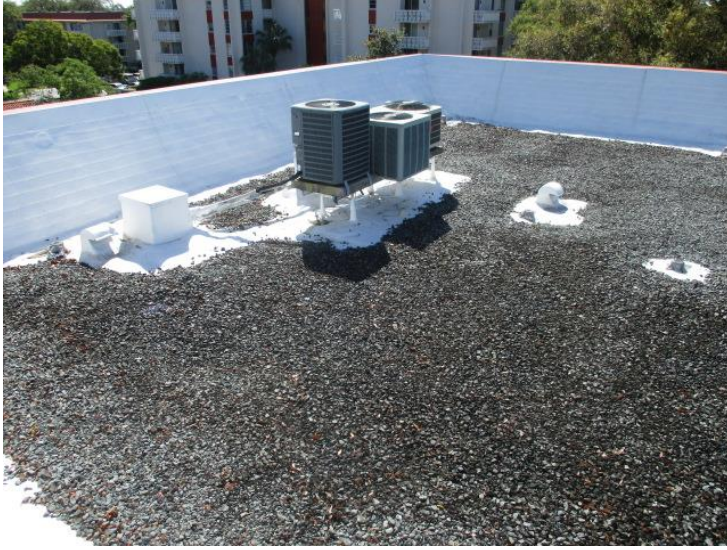
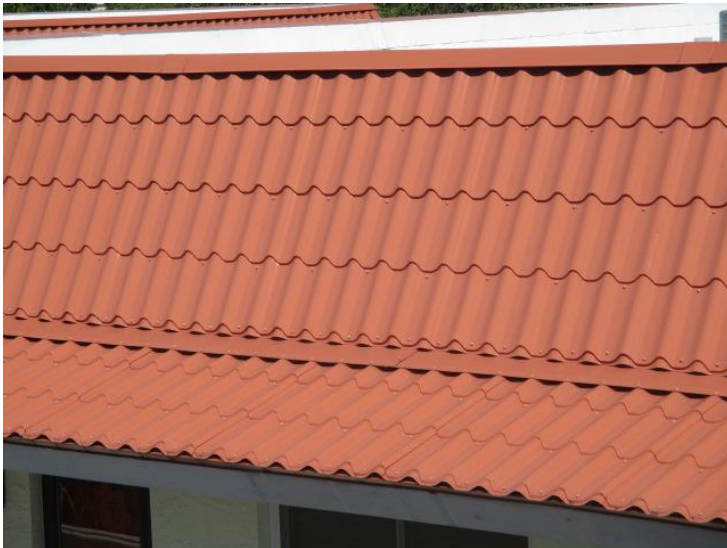
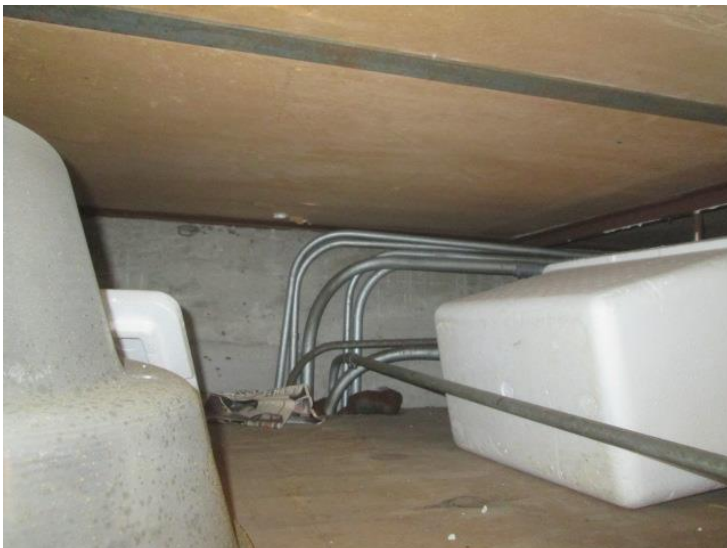
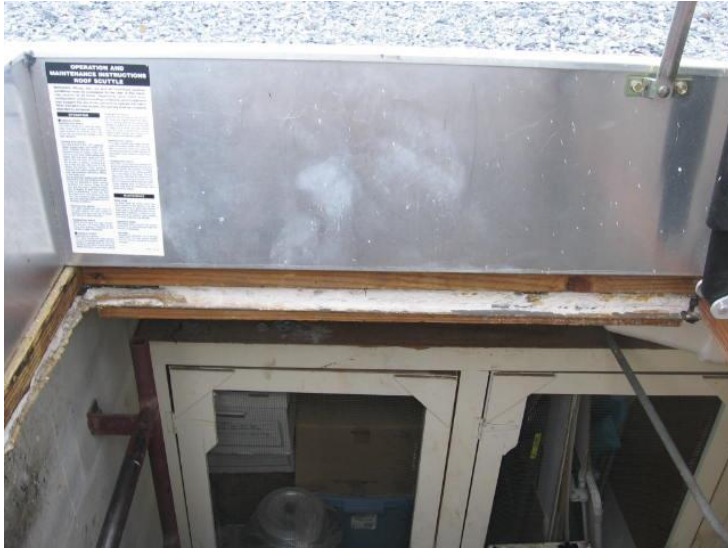
| 2. <b><u>Roof Covering:</u></b><br>Comments: | <b>FBC Equivalent</b><br>The roof covering was replaced in 2004. The roof permit was confirmed and the permit number is BCP2004-02546. This roof was verified as meeting the building code requirements outlined on the mitigation affidavit. |

Roof Construction
